# Los Gatos Creek Trail Reach 4 Riparian Mitigation Year 1 (2008) Monitoring Report

## Los Gatos Creek Trail Reach 4 Riparian Mitigation Year 1 (2008) Monitoring Report

City of San Jose  
Department of Public Works, City Facilities Architectural Services

December 2, 2008

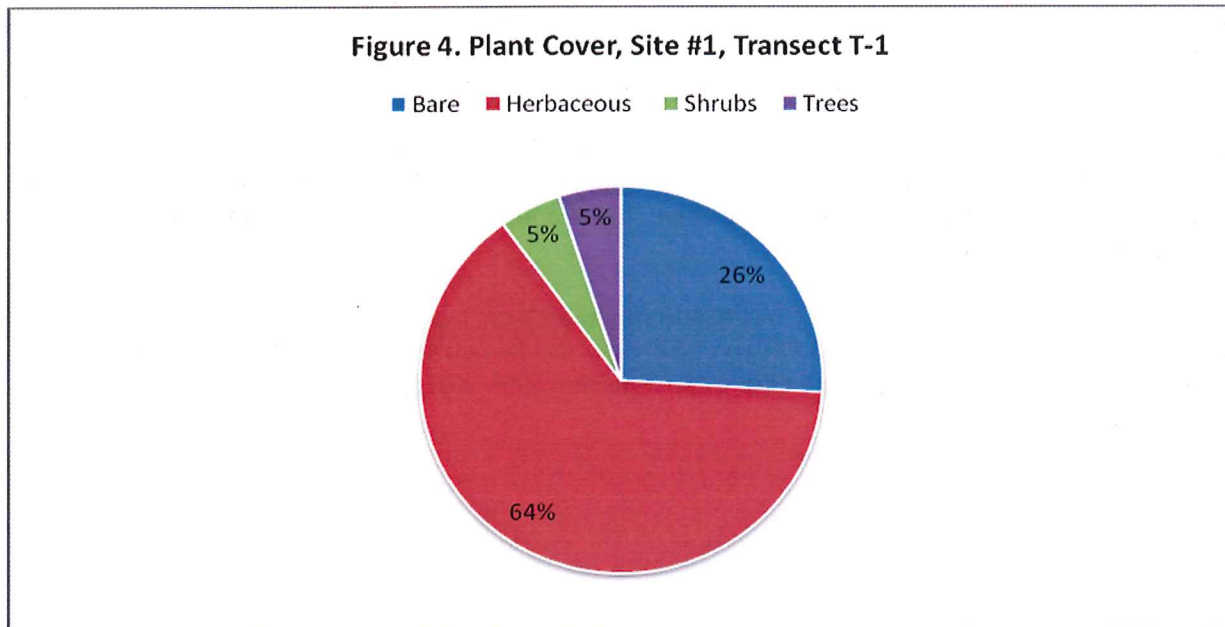
*Site #1 (Meridian Avenue).* The two transects at this site measure 32 meters (T-1, 216° heading) and 28 meters (T-2, 190° heading). Plant cover along transect T-1 was recorded at 74%. Tree cover was recorded at 5%, provided by California buckeye. Shrub cover totaled 5% and was provided by holly-leaved cherry; this data is presented in Figure 4.

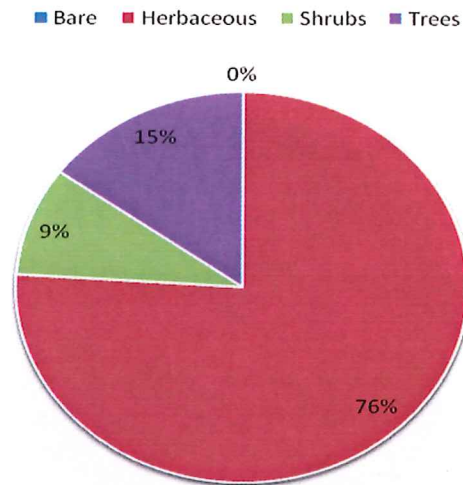
**Figure 5. Plant Cover, Site #1, Transect T-2**

Plant cover along transect T-2 was recorded at 100%; with tree cover providing 15% cover (provided by California walnut, blue elderberry and coast live oak). Shrub cover totaled 9%, with cover provided by California blackberry and coyote brush. This data is presented in Figure 5.

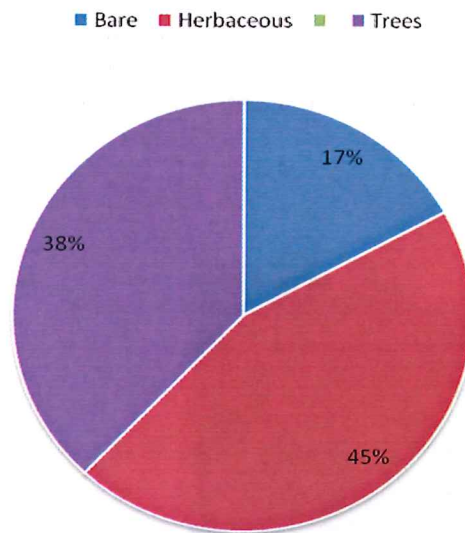
**Figure 6. Plant Cover, Site #2, Transect T-1**

*Site #2 (Auzerais Avenue).* The two transects at this site measure 25 meters (T-1, 174° heading) and 30 meters (T-2, 122° heading). Plant cover along transect T-1 was recorded at 83%. Tree cover was recorded at 38% by coast live oak, willow (pre-existing mature trees) and blue elderberry. No shrubs provided cover along this transect, yet herbaceous cover (grasses) was 45%. Bare areas were covered by mulch. This data is presented in Figure 6.

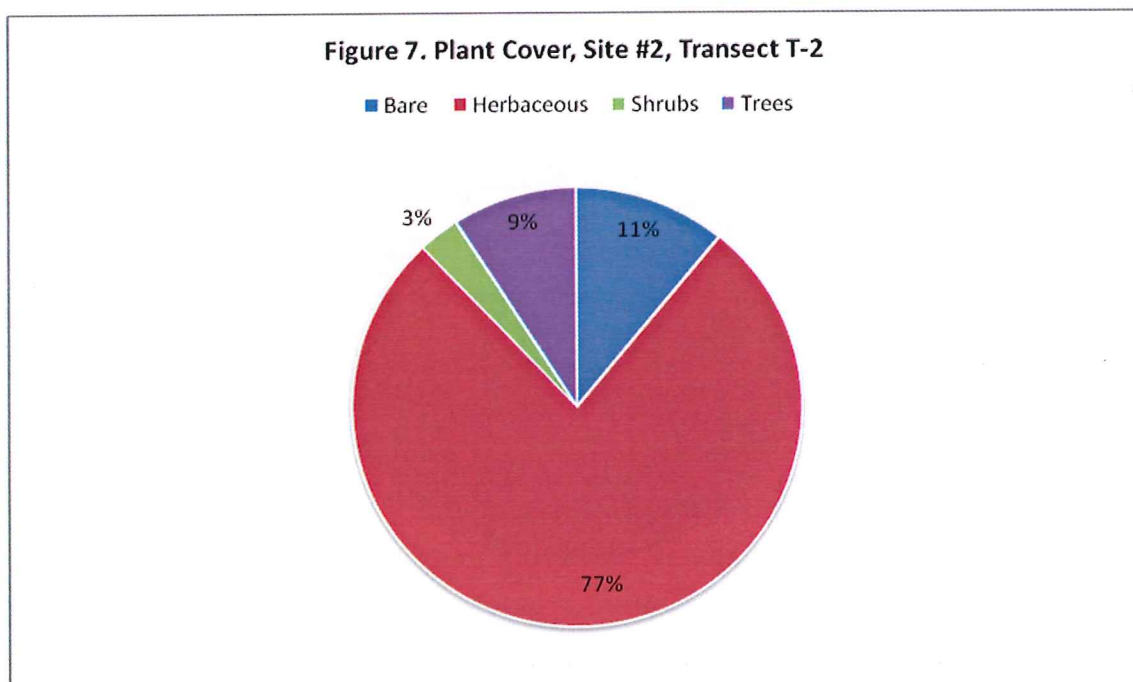
Plant cover along transect T-2 was recorded at 89%, with tree cover providing 9% cover (provided by coast live oak. Shrub cover totaled 3%, with cover provided by coyote brush. Herbaceous cover (provided by grasses) is 77%. This data is presented in Figure 7.

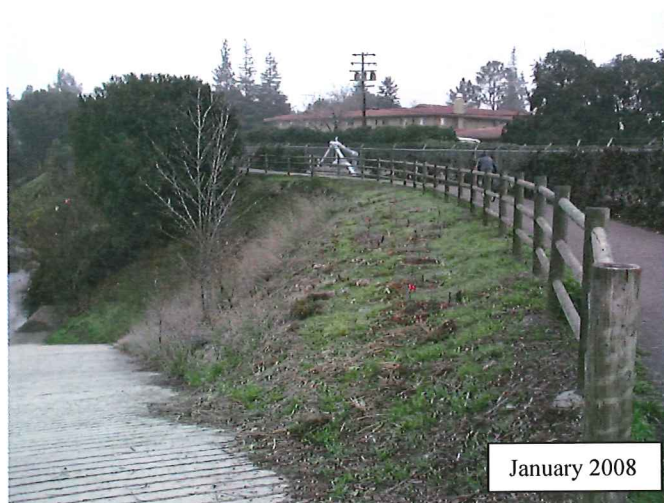
**Site #1 (Meridian Avenue).** The Year 1 (2008) condition on Site #1 (Meridian Avenue) is depicted in Figures 8 through 11. Figures 8A and 8B depict the downstream plantings adjacent to the Los Gatos Creek Trail in January 2008 (immediately after installation) and in October 2008. Figure 8B also shows transect T-1.

Figure 8A. Photo station A, downstream portion of Site #1, showing plantings adjacent to trail, January 2008.

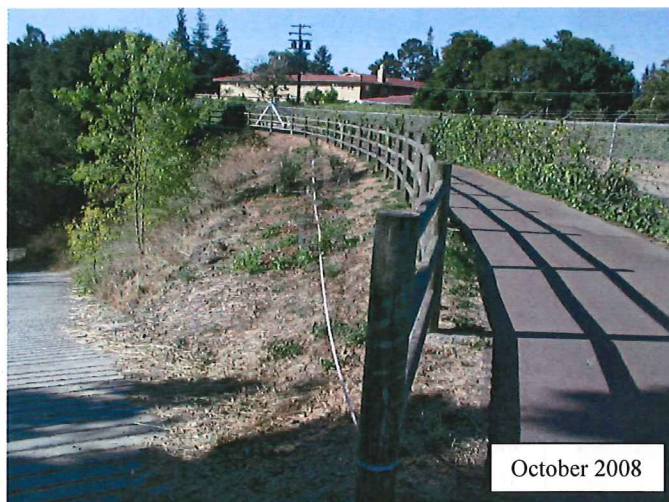
Figure 8B. Downstream portion of Site #1, showing plantings adjacent to trail, October 2008, location of Transect T-1 (heading 216°), (photo station A).

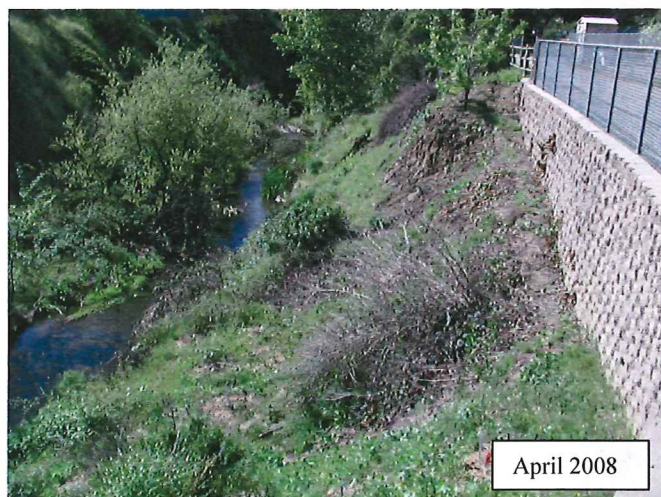
Figures 9A and 9B depict the upstream section in January 2008 and in October 2008. Figure 10 depicts the vegetation along transect T-2 in October 2008. Figure 11 shows a typical planting (box elder).

Figure 9A. Photo station B, upstream portion of Site #1, showing plantings down slope of retaining wall, April 2008.

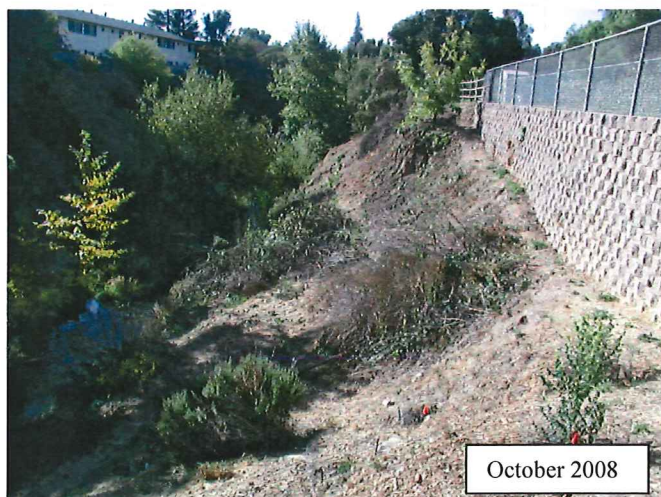
Figure 9B. Upstream portion of Site #1, showing plantings down slope of retaining wall, October 2008 (photo station B).

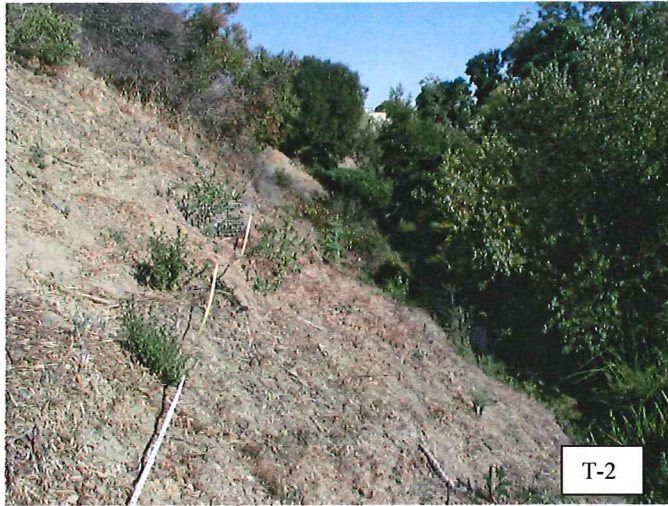
Figure 10. Transect T-2 along slope, showing plantings along transect, (heading 190°), October 2008

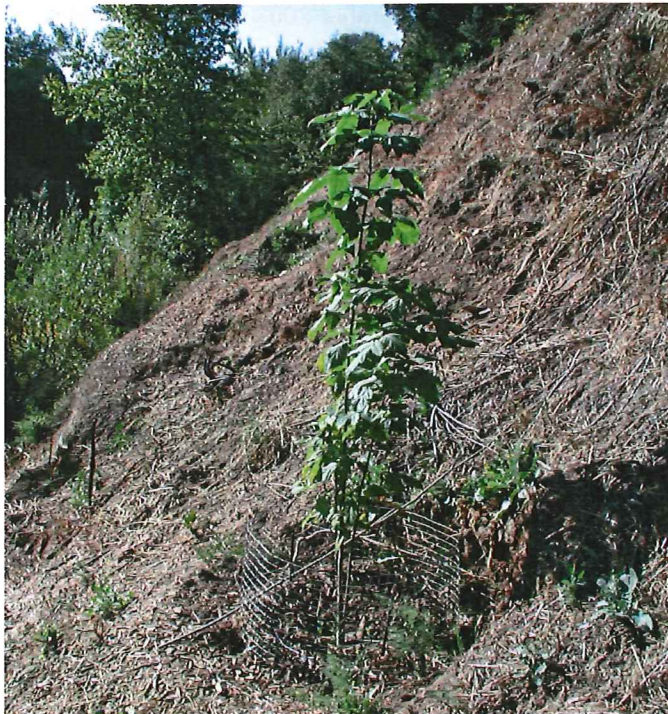
Figure 11. Box elder plantings on creek bank, October 2008

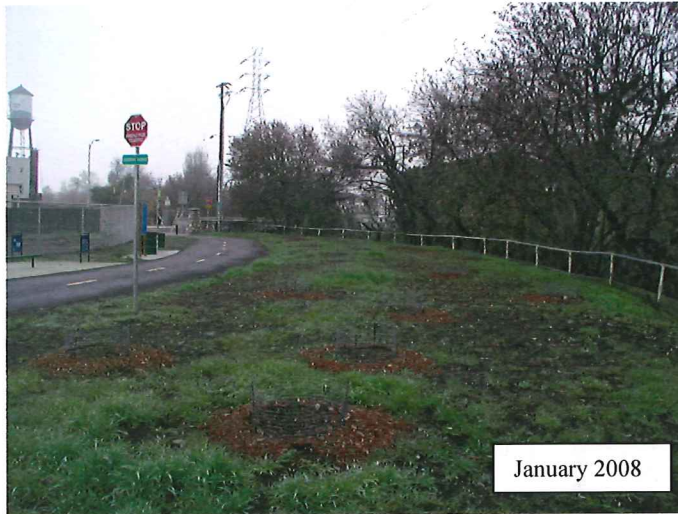
**Site #2 (Auzerais Avenue).** The Year 1 (2008) condition on Site #2 (Auzerais Avenue) is depicted in Figures 12 through 17. Figures 12A and 12B depict the revegetation area looking toward Auzerais Avenue in January 2008 (immediately after installation) and in October 2008. This is photo station A

Figure 12A. Photo station A, looking toward Auzerai Avenue, January 2008.

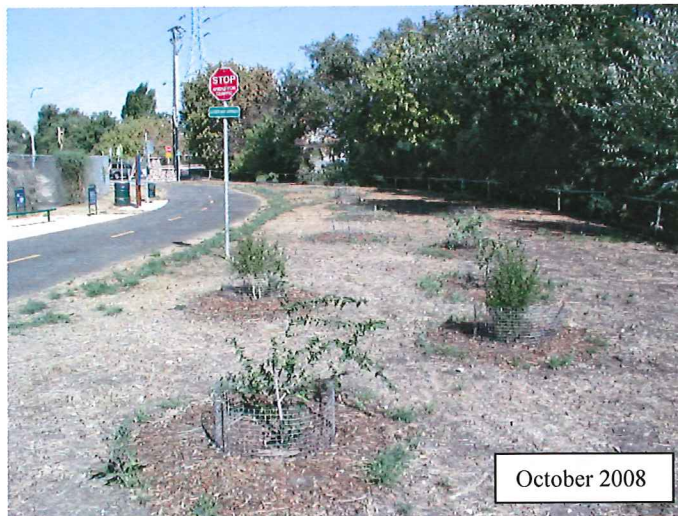
Figure 12B. Photo station A, looking toward Auzerai Avenue, October 2008.

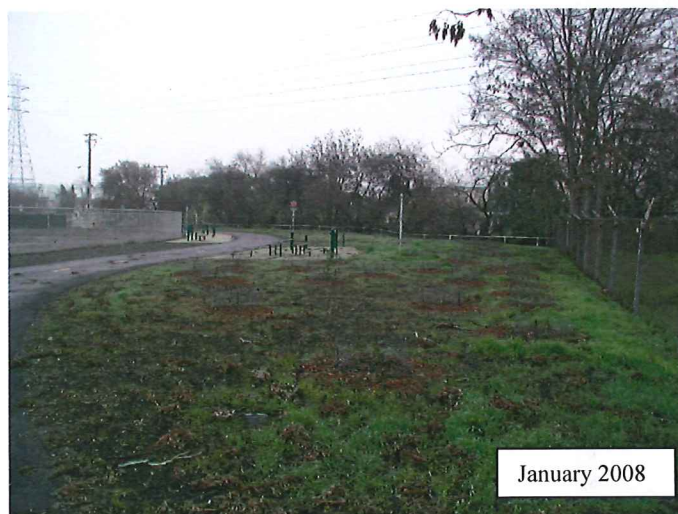
Figures 13A and 13B depict the upstream section in January 2008 and in October 2008. This is photo station B, looking toward Los Gatos Creek. Figures 14 and 15 depict transects T-1 and T-2, respectively. Figures 16 and 17 show the approximately one-year condition of two coast live oak tree plantings (October 2008).

Figure 13A. Photo station B, looking toward Los Gatos Creek, January 2008.

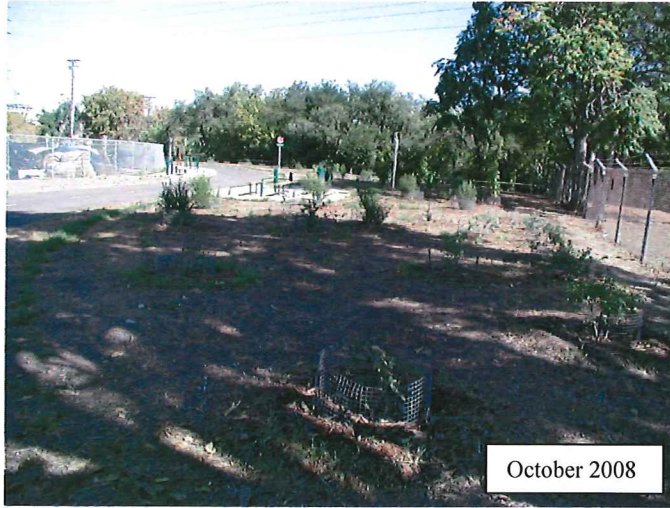
Figure 13B. Photo station B, looking toward Los Gatos Creek, October 2008.

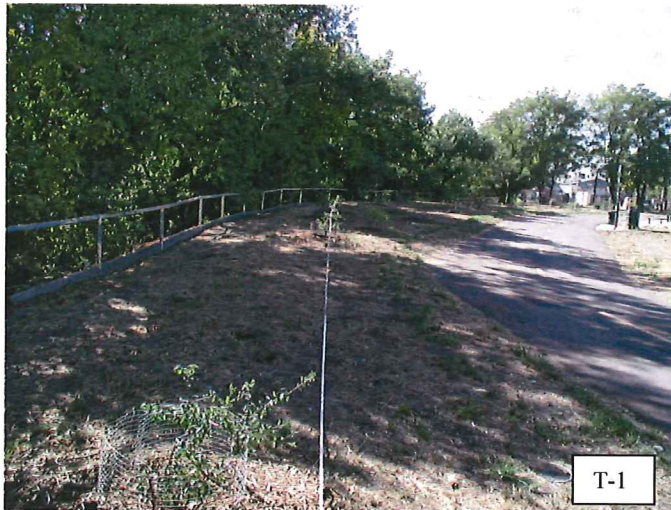
Figure 14. Transect T-1, looking southward from Auzeris Avenue (heading 174°), October 2008.

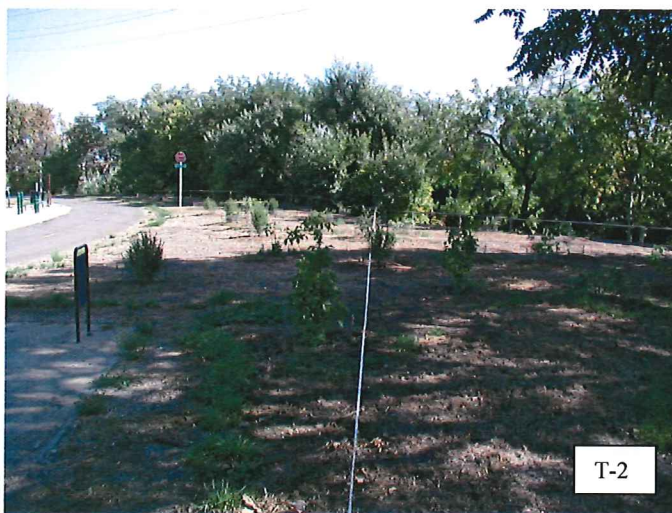
Figure 15. Transect T-2, looking toward Los Gatos Creek (heading 122°), October 2008.

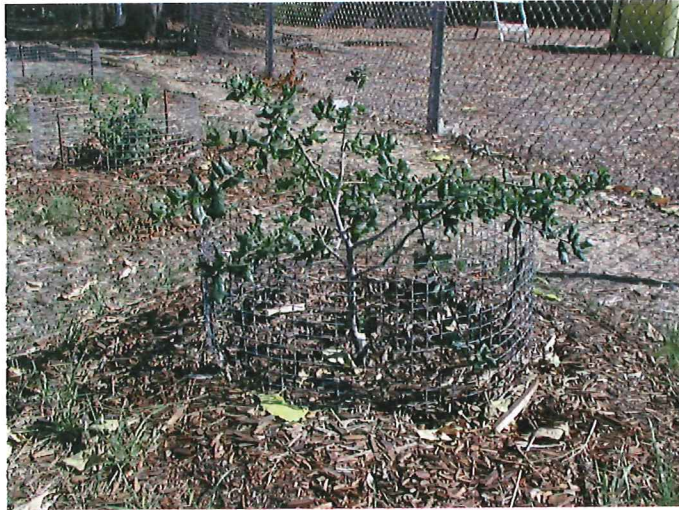
Figure 16. Coast live oak planting, October 2008.

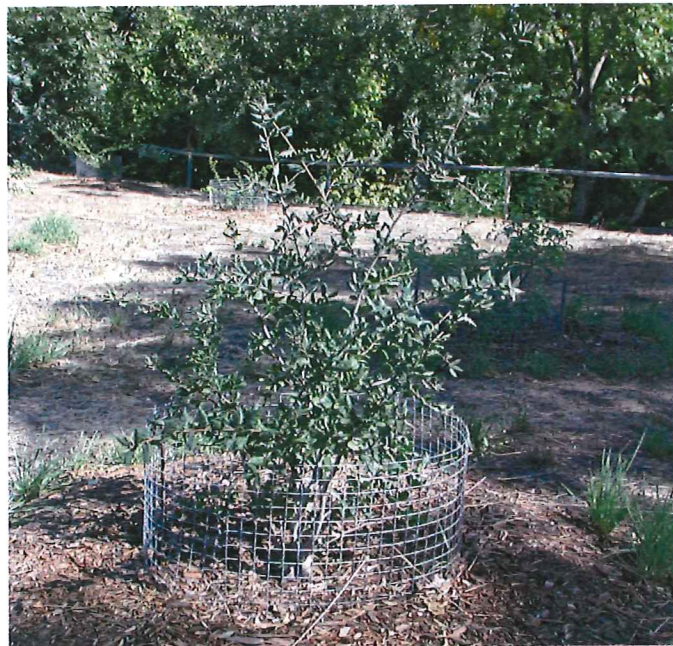
Figure 17. Coast live oak planting, October 2008.
